NC Department of Transportation
RAIL DIVISION

TRAFFIC SEPARATION STUDY

FEBRUARY 2017

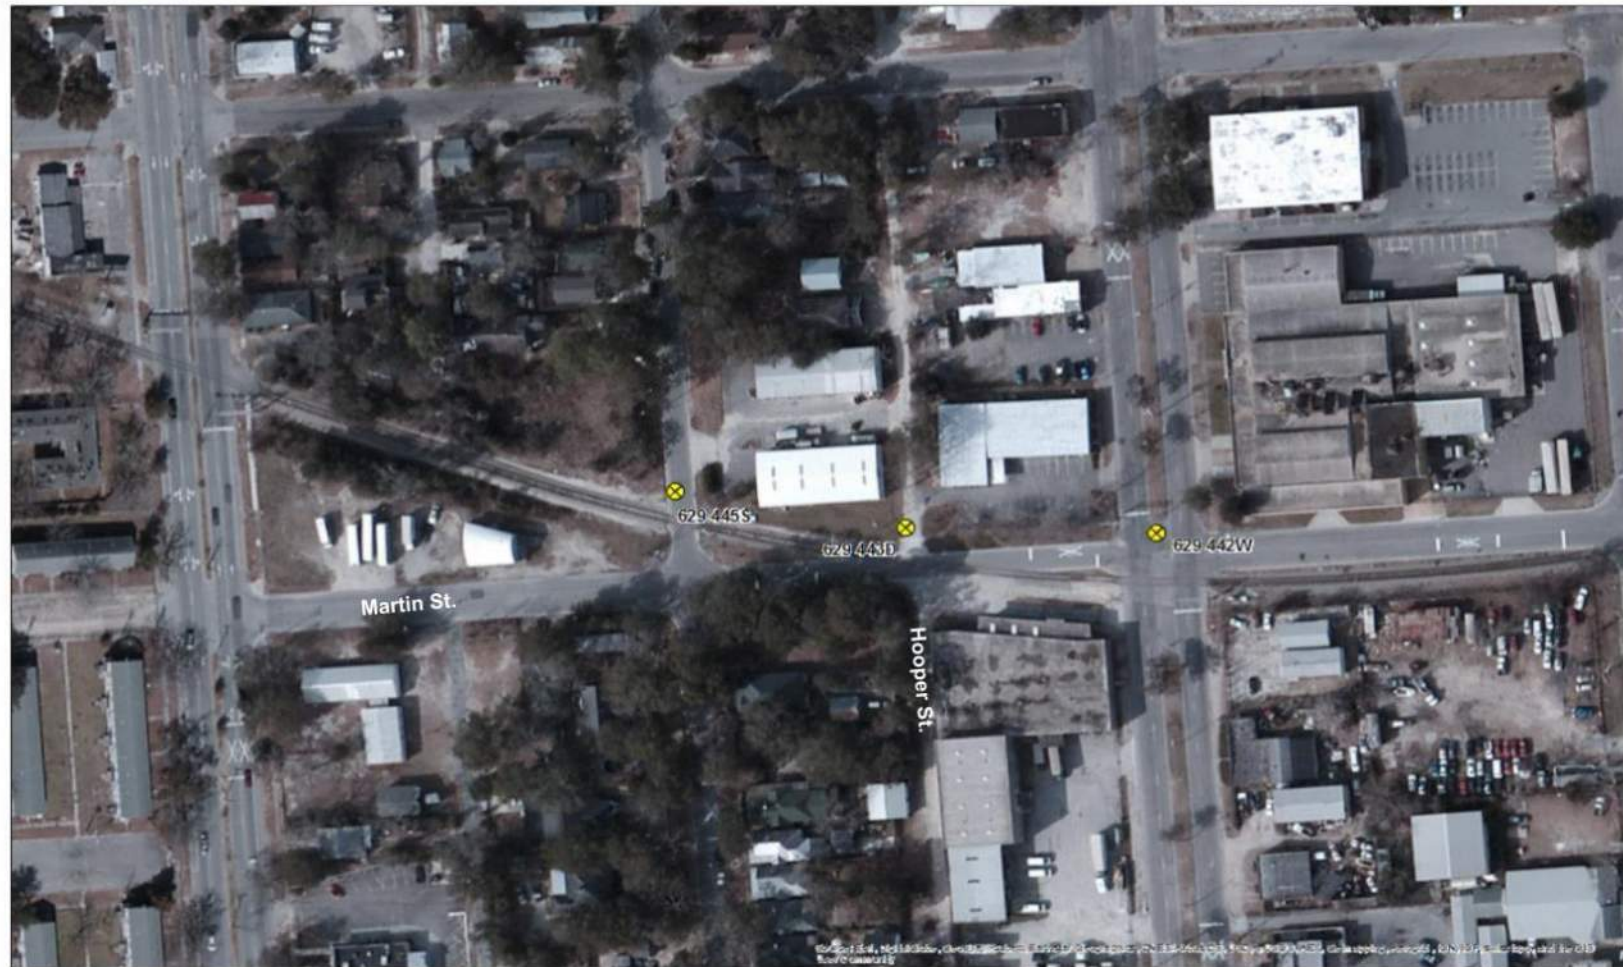
Figure 4 – Hooper Street/S. Martin Street, Crossing Inventory

Crossing Number	Milepost	Railroad	Street Name	Street Classification	Warning Device	Land Use
629 443D	246.48	CSX	Hooper Street	Local	None	Industrial
24 Hour ADT	24 Hour Train Volume	Accident History	Transit Route	School Bus Route	Truck Route	
393	3/day; 5 days/week		No	No	n/a	
Preemption	Humped Crossing	Crossing Condition Geometry	Crossing Surface Condition	Crossing Condition Sight	Redundant Crossing	
<input checked="" type="checkbox"/>	<input type="checkbox"/>	Fair	Poor	Good	No	
Economic Impact if Closed	Feasibility of Roadway Improvements	Grade Separation Investigation	Need for Enhanced Warning Devices			
Low	High	Low	No			
Aerials

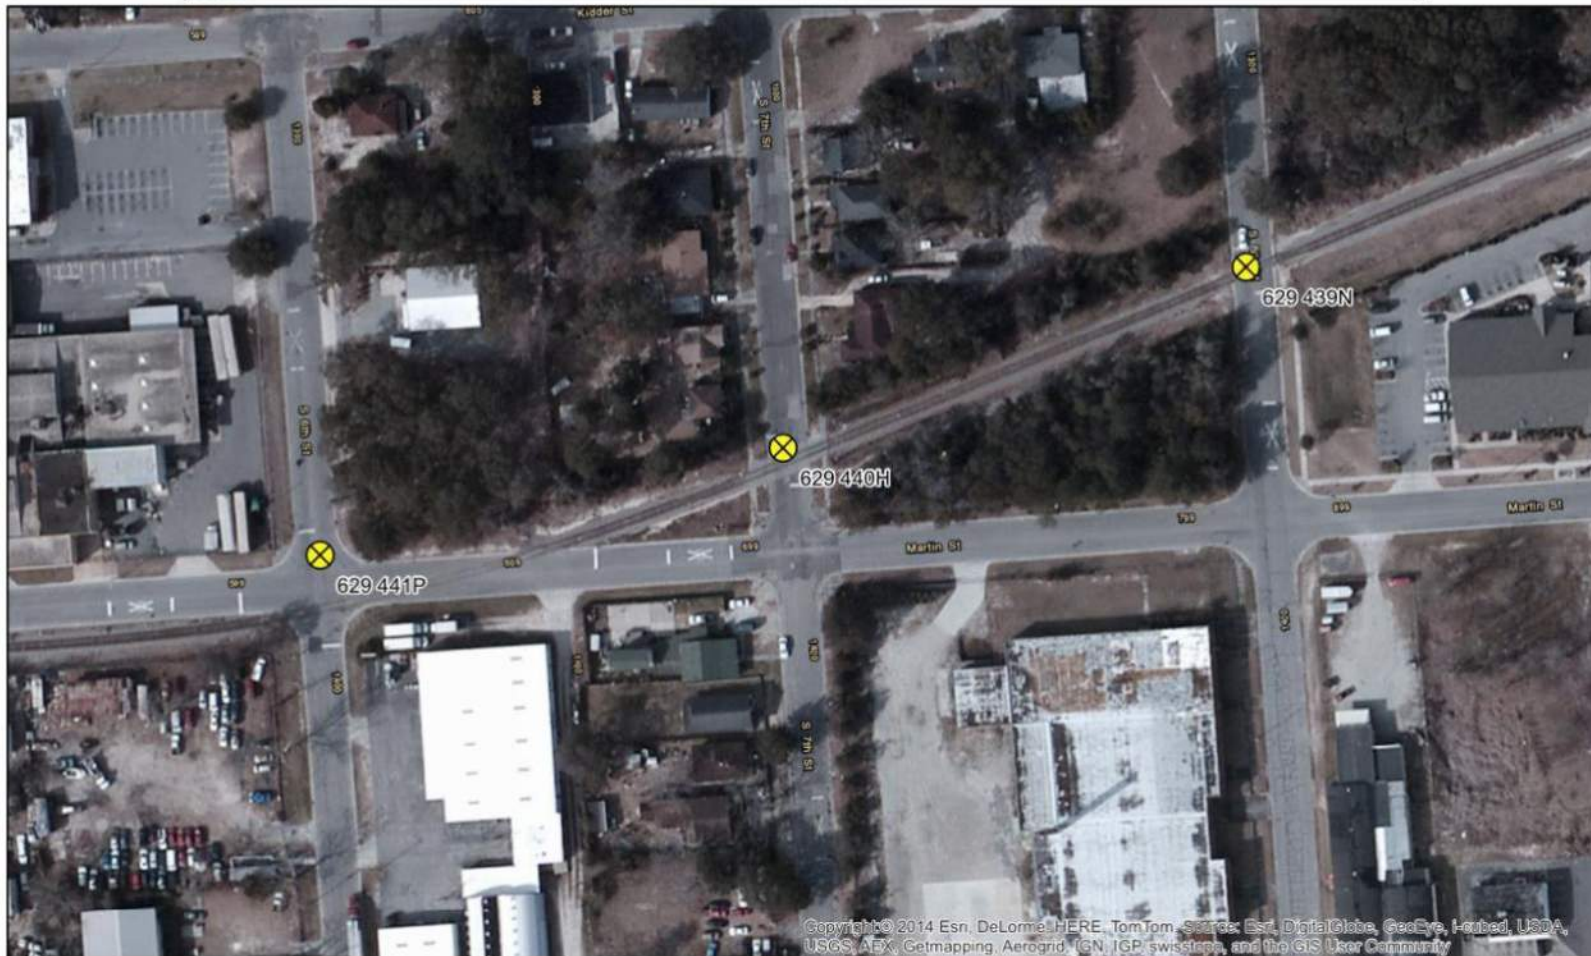
Figure 10 – S. 7th Street, Crossing Inventory

Crossing Number	Milepost	Railroad	Street Name	Street Classification	Warning Device	Land Use
629 440H	249.42	CSX	S 7th Street	Local	None	Residential
24 Hour ADT	24 Hour Train Volume	Accident History	Transit Route	School Bus Route	Truck Route	
574	3/day; 5 days/week		No	Yes - Avg.: 3/day	n/a	
Preemption	Humped Crossing	Crossing Condition Geometry	Crossing Surface Condition	Crossing Condition Sight	Redundant Crossing	
<input checked="" type="checkbox"/>	<input type="checkbox"/>	Fair	Poor	Poor	No	
Economic Impact if Closed	Feasibility of Roadway Improvements	Grade Separation Investigation	Need for Enhanced Warning Devices			
Low	High	Low	Yes			
<i>Notes: Rail crosses at both 6th Street and Martin Street at same location</i>

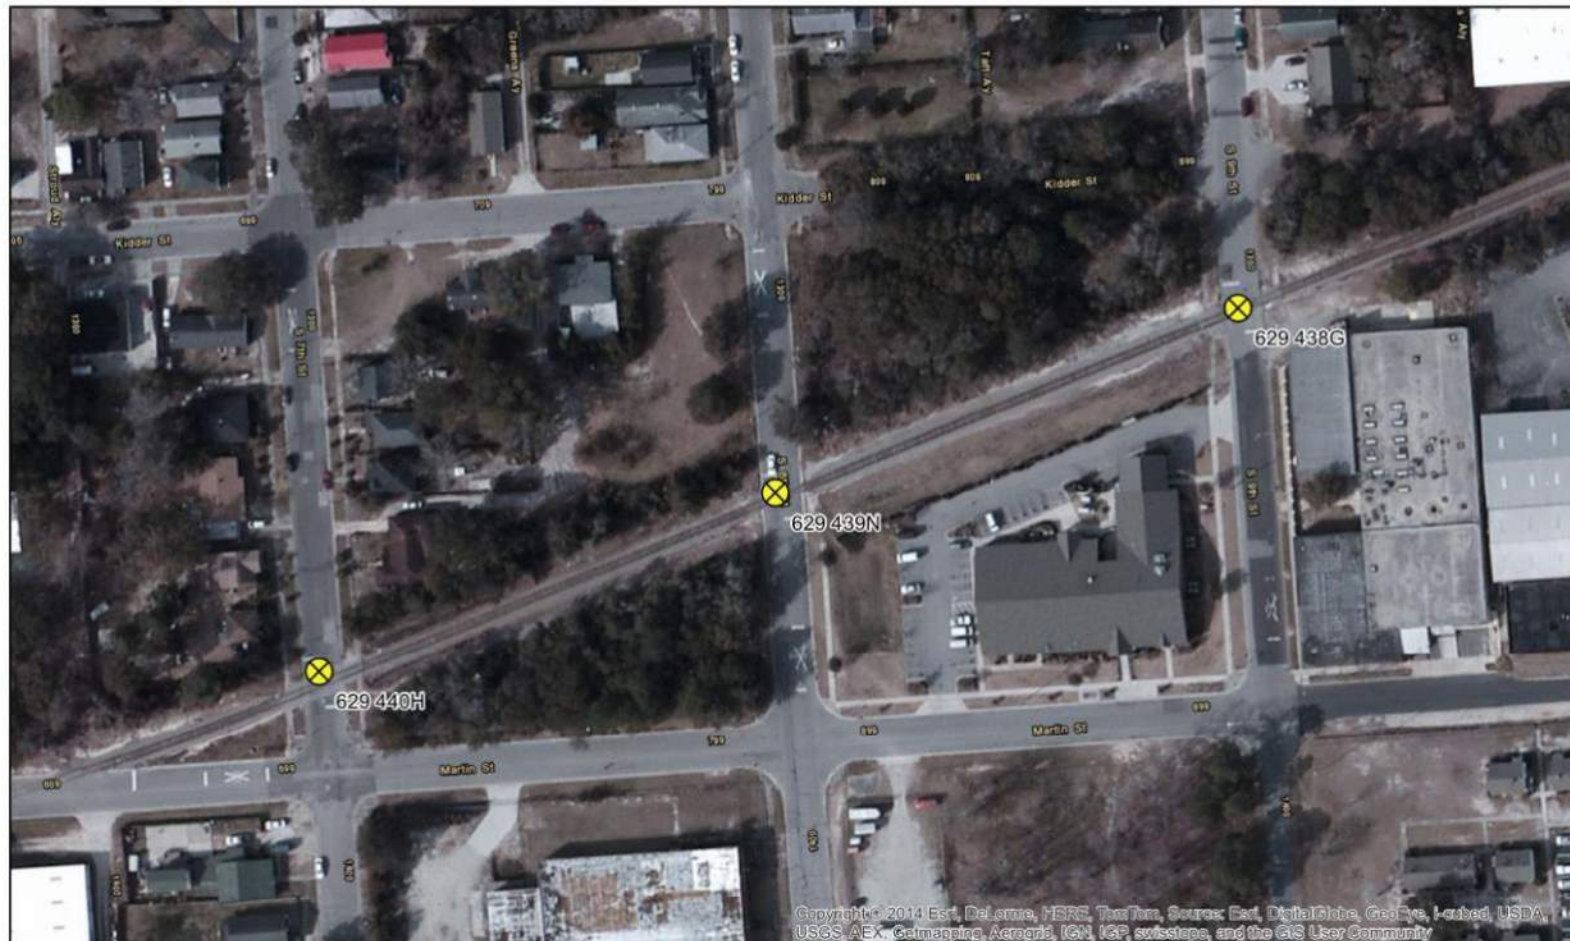
Figure 12 – S. 8th Street, Crossing Inventory

Crossing Number	Milepost	Railroad	Street Name	Street Classification	Warning Device	Land Use
629 439N	249.50	CSX	S 8th Street	Local	None	Residential
24 Hour ADT	24 Hour Train Volume	Accident History	Transit Route	School Bus Route	Truck Route	
763	3/day; 5 days/week		No	Yes - Avg.: 4/day	n/a	
Preemption	Humped Crossing	Crossing Condition Geometry	Crossing Surface Condition	Crossing Condition Sight	Redundant Crossing	
<input checked="" type="checkbox"/>	<input type="checkbox"/>	Fair	Poor	Fair	No	
Economic Impact if Closed	Feasibility of Roadway Improvements	Grade Separation Investigation	Need for Enhanced Warning Devices			
Low	High	Low	Yes			
Aerials

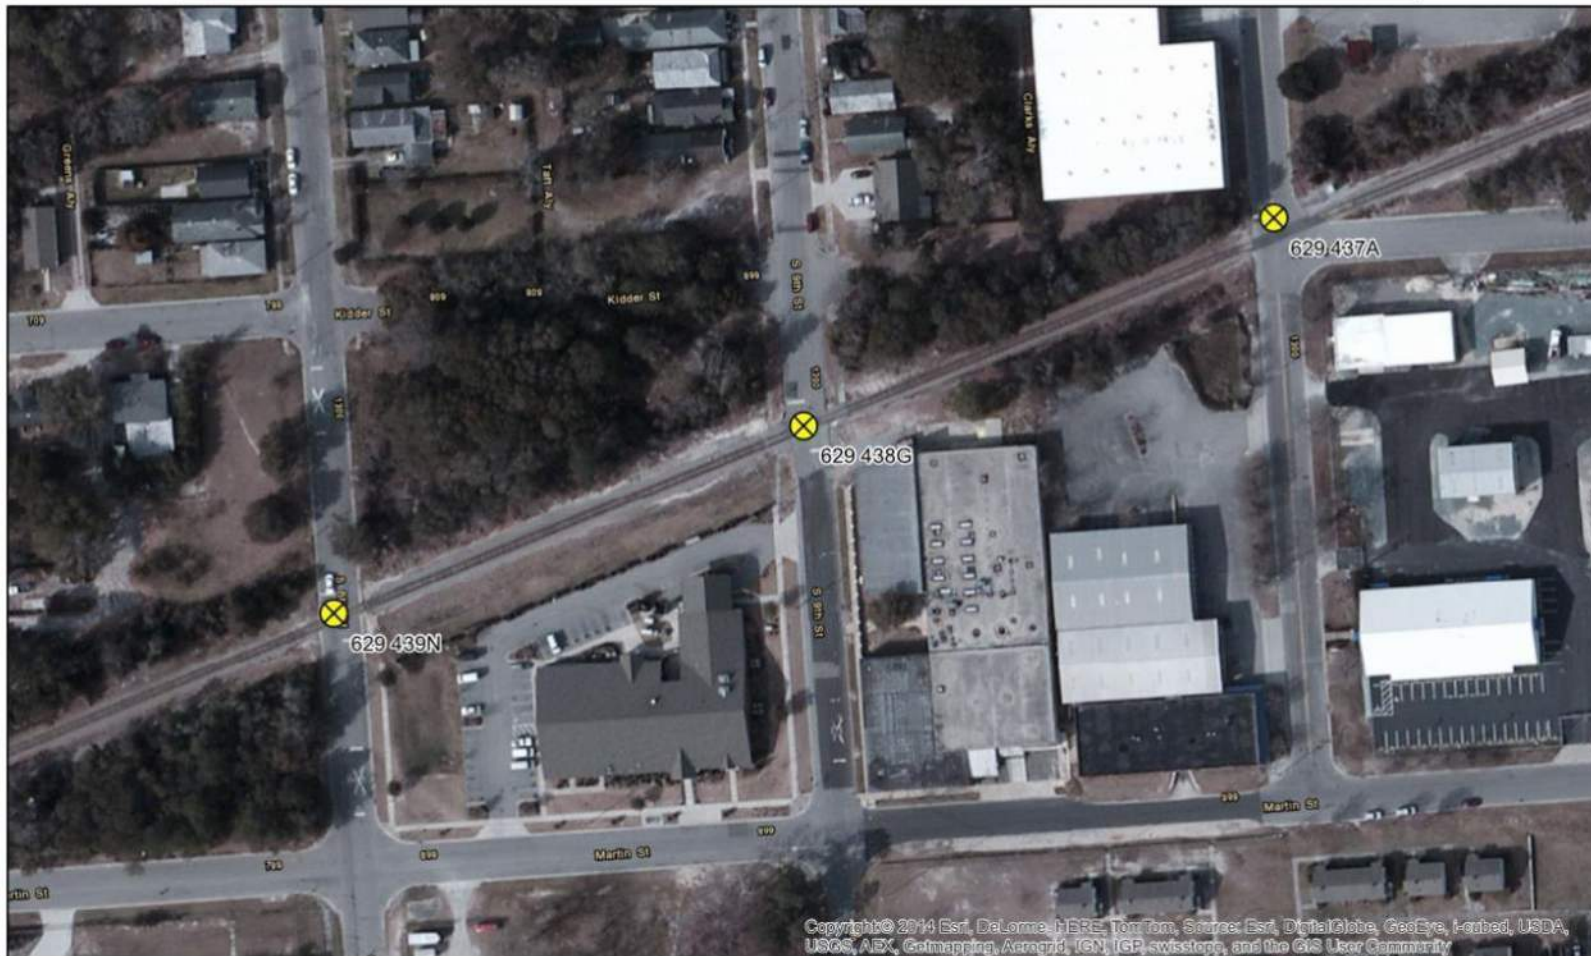
Figure 14 – S. 9th Street, Crossing Inventory

Crossing Number	Milepost	Railroad	Street Name	Street Classification	Warning Device	Land Use
629 438G	249.27	CSX	S 9th Street	Local	None	Institutional
24 Hour ADT	24 Hour Train Volume	Accident History	Transit Route	School Bus Route	Truck Route	
570	3/day; 5 days/week		No	Yes - Avg.: 7/day	n/a	
Preemption	Humped Crossing	Crossing Condition Geometry	Crossing Surface Condition	Crossing Condition Sight	Redundant Crossing	
<input checked="" type="checkbox"/>	<input type="checkbox"/>	Fair	Poor	Fair	No	
Economic Impact if Closed	Feasibility of Roadway Improvements	Grade Separation Investigation	Need for Enhanced Warning Devices			
Low	High	Low	Yes			
Aerials

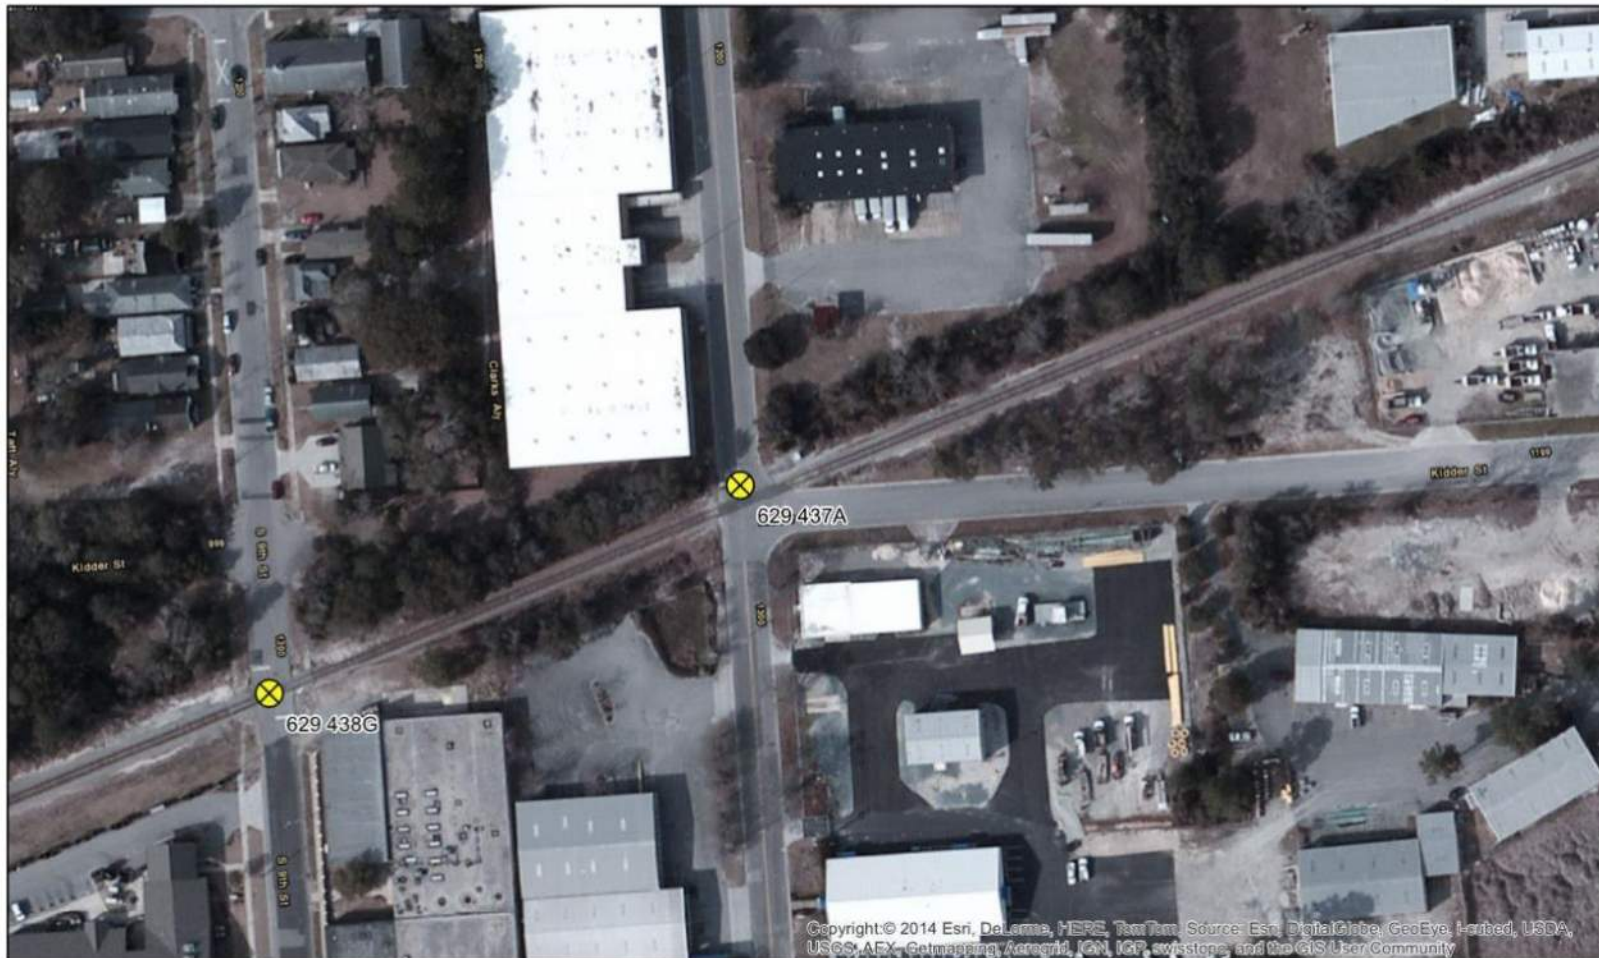
Figure 16 – S. 10th Street, Crossing Inventory

Crossing Number	Milepost	Railroad	Street Name	Street Classification	Warning Device	Land Use
629 437A	249.19	CSX	S 10th Street	Local	CB; MMFL; other	Industrial
24 Hour ADT	24 Hour Train Volume	Accident History	Transit Route	School Bus Route	Truck Route	
523	3/day; 5 days/week		No	No	n/a	
Preemption	Humped Crossing	Crossing Condition Geometry	Crossing Surface Condition	Crossing Condition Sight	Redundant Crossing	
<input checked="" type="checkbox"/>	<input type="checkbox"/>	Poor	Poor	Fair	No	
Economic Impact if Closed	Feasibility of Roadway Improvements	Grade Separation Investigation	Need for Enhanced Warning Devices			
Low	High	Low	No

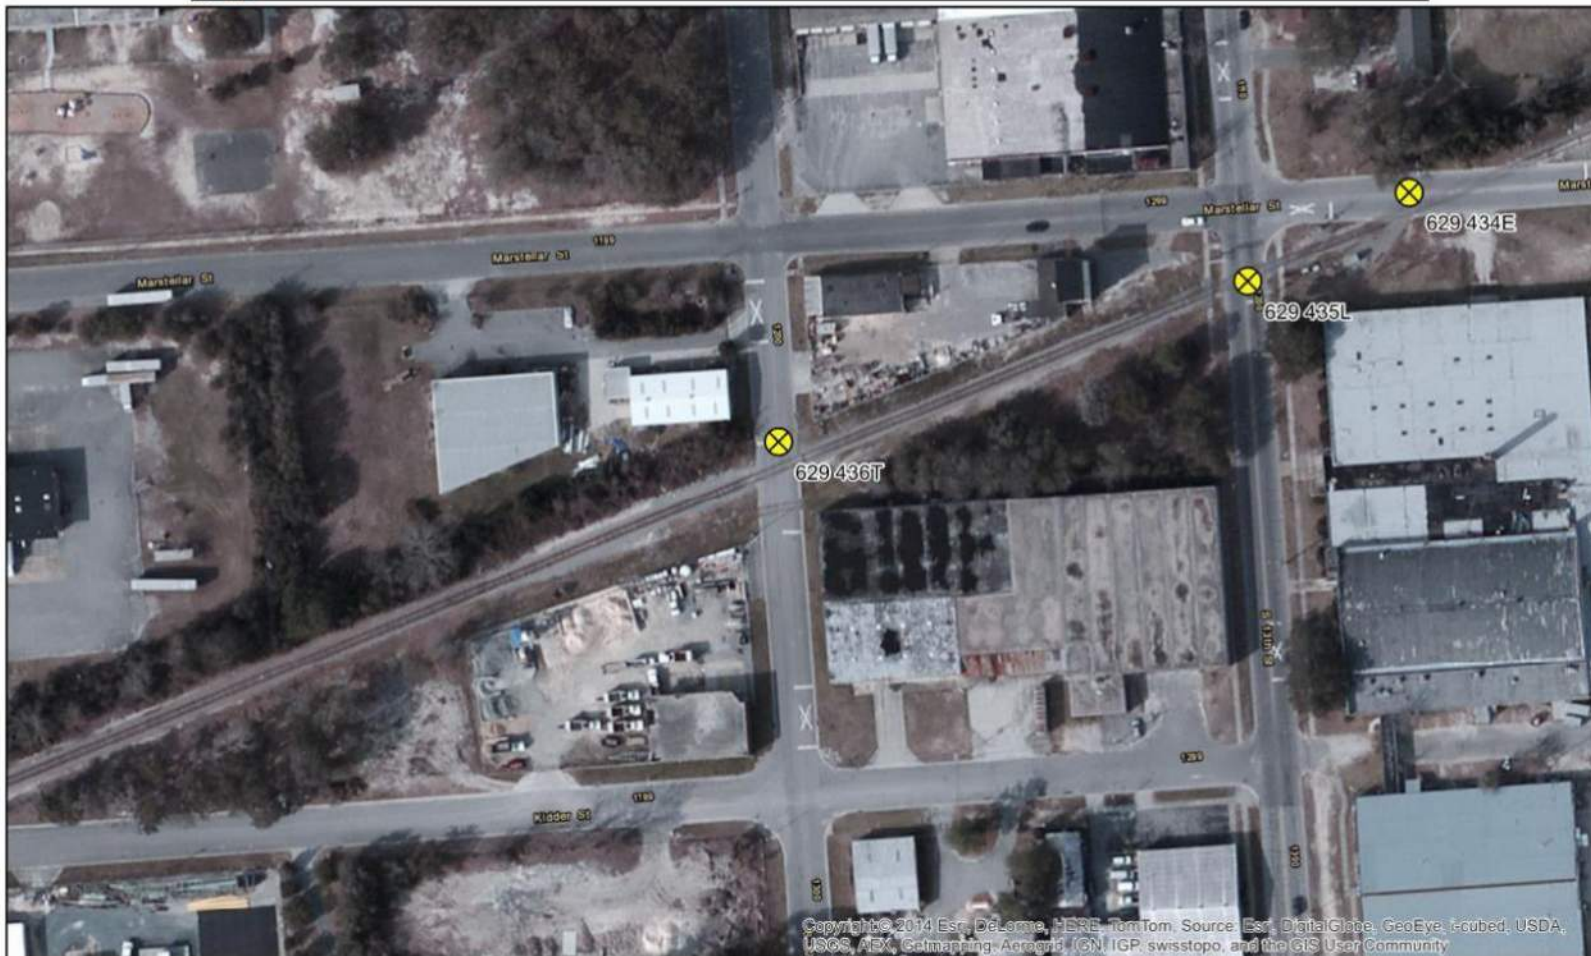
Figure 18 – S. 12th Street, Crossing Inventory

Crossing Number	Milepost	Railroad	Street Name	Street Classification	Warning Device	Land Use
629 436T	249.03	CSX	S 12th Street	Local	None	Industrial
24 Hour ADT	24 Hour Train Volume	Accident History	Transit Route	School Bus Route	Truck Route	
201	3/day; 5 days/week		No	No	n/a	
Preemption	Humped Crossing	Crossing Condition Geometry	Crossing Surface Condition	Crossing Condition Sight	Redundant Crossing	
<input checked="" type="checkbox"/>	<input checked="" type="checkbox"/>	Poor	Fair	Good	No	
Economic Impact if Closed	Feasibility of Roadway Improvements	Grade Separation Investigation	Need for Enhanced Warning Devices			
Low	High	Low	Yes			
Aerials

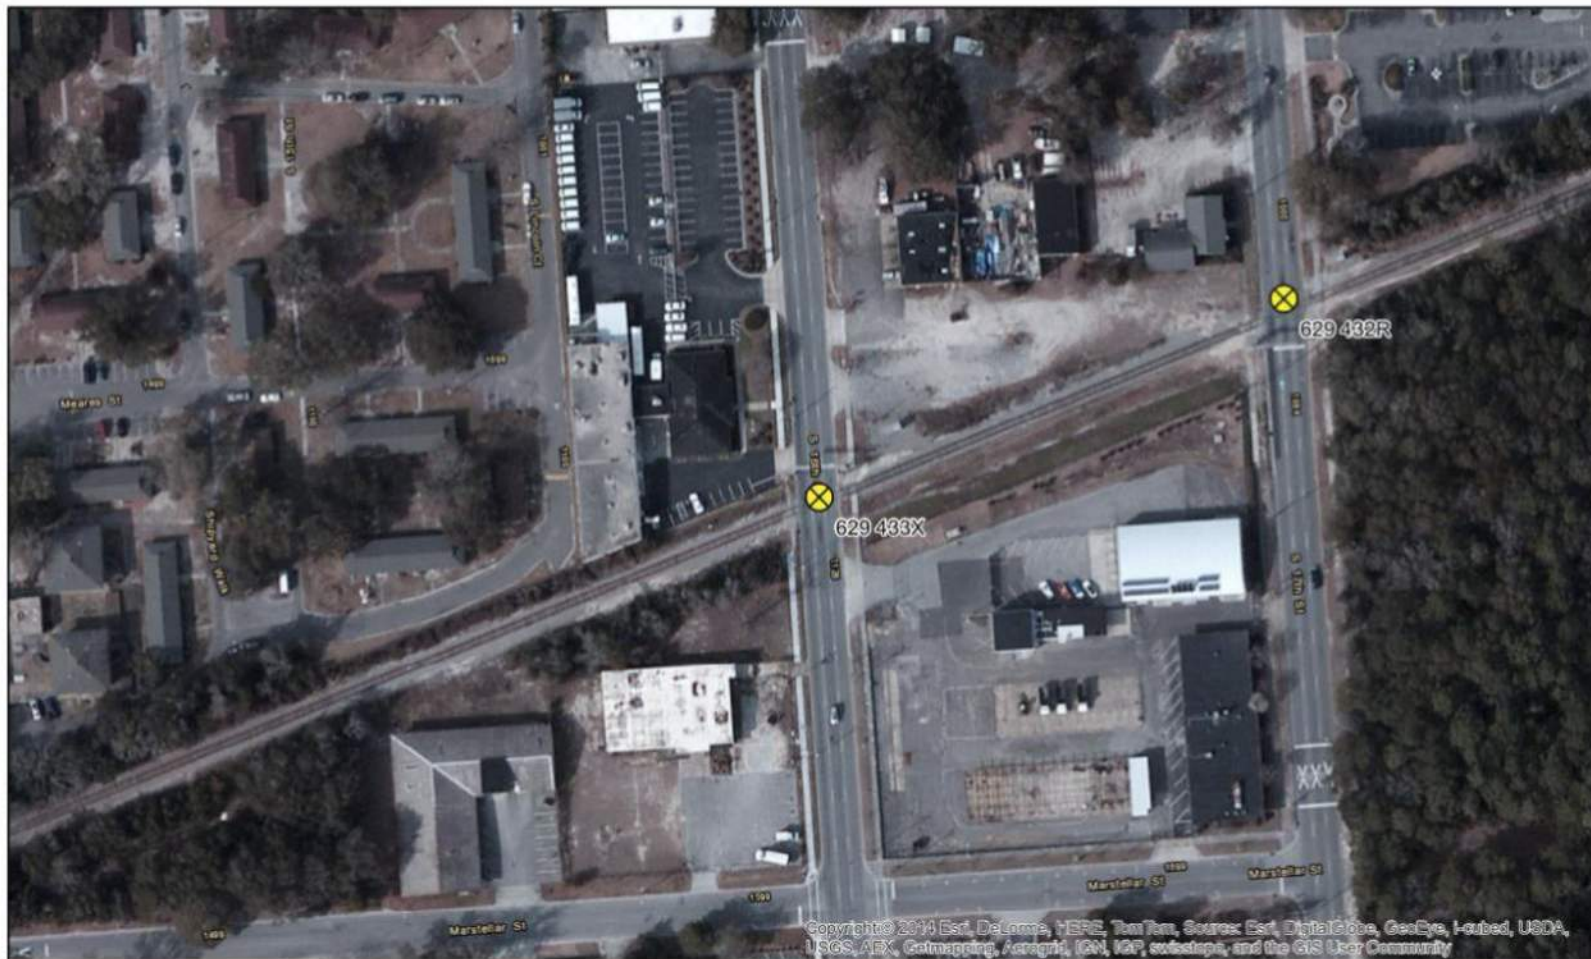
Figure 24 – S. 16th Street, Crossing Inventory

Crossing Number	Milepost	Railroad	Street Name	Street Classification	Warning Device	Land Use
629 433X	248.72	CSX	S 16th Street	Urban - other Principal	Gates, MMFL, CFL	Industrial
24 Hour ADT	24 Hour Train Volume	Accident History	Transit Route	School Bus Route	Truck Route	
17,194	3/day; 5 days/week		Yes	Yes - Avg.: 25/day	n/a	
Preemption	Humped Crossing	Crossing Condition Geometry	Crossing Surface Condition	Crossing Condition Sight	Redundant Crossing	
<input checked="" type="checkbox"/>	<input type="checkbox"/>	Fair	Poor	Good	No	
Economic Impact if Closed	Feasibility of Roadway Improvements	Grade Separation Investigation	Need for Enhanced Warning Devices			
Medium	High	Low	No			
Aerials

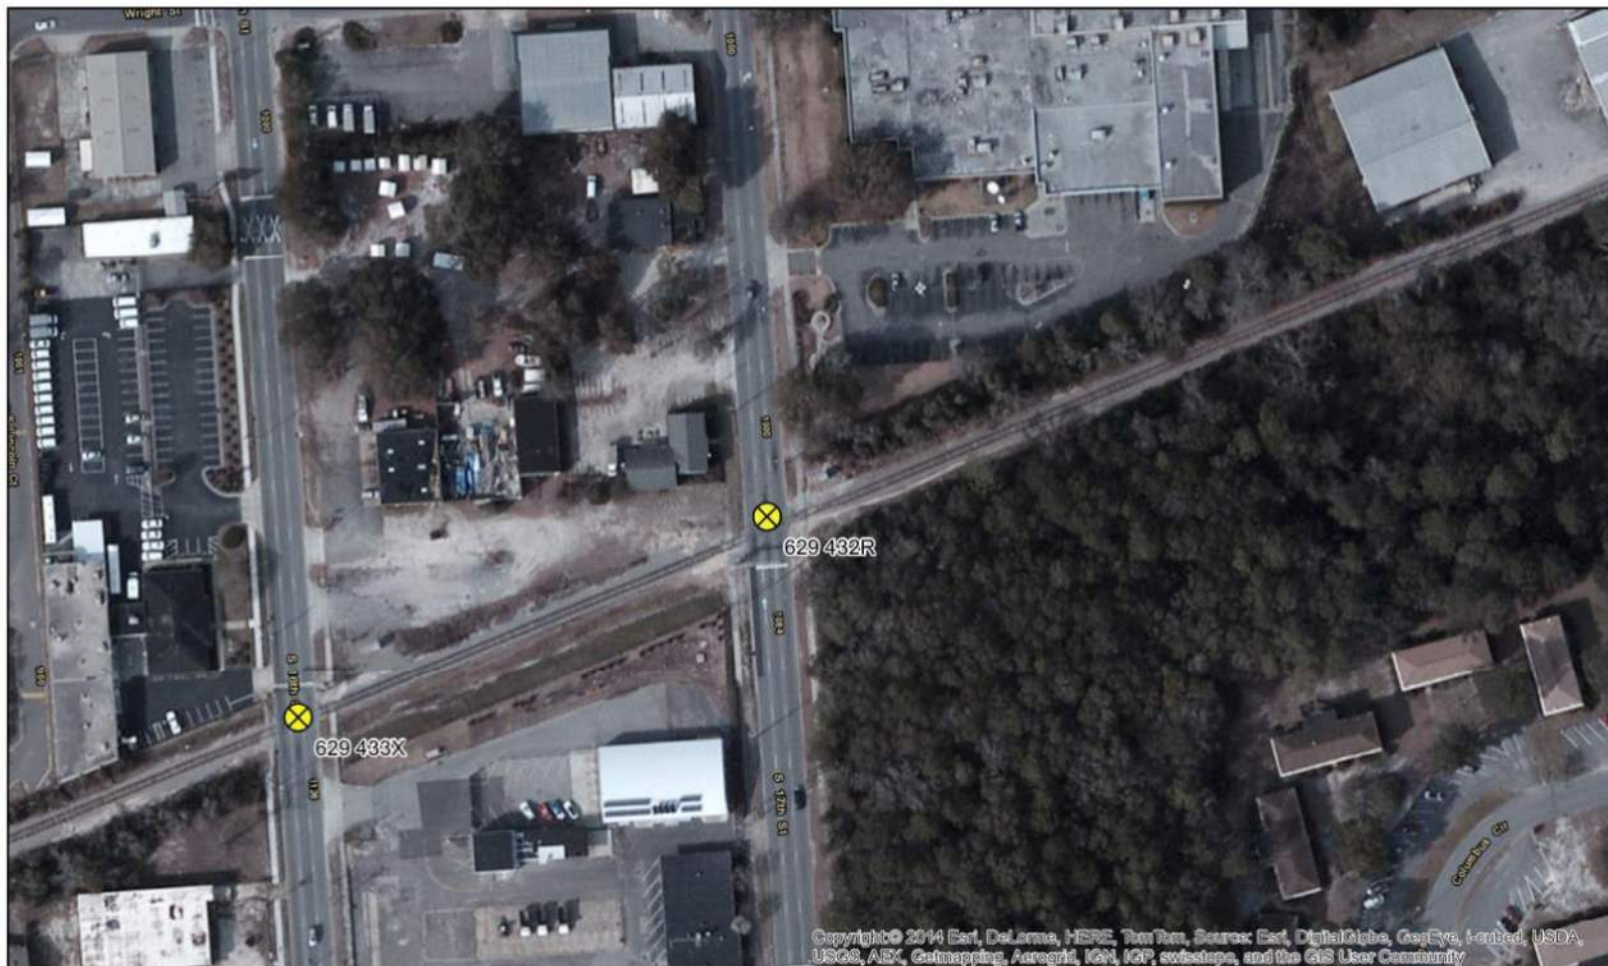
Figure 26 – S. 17th Street, Crossing Inventory

Crossing Number	Milepost	Railroad	Street Name	Street Classification	Warning Device	Land Use
629 432R	248.64	CSX	S 17th Street	Urban - other principal	Gates, MMFL, CFL	Commercial
24 Hour ADT	24 Hour Train Volume	Accident History	Transit Route	School Bus Route	Truck Route	
17,398	3/day; 5 days/week		No	Yes - Avg.: 20/day	n/a	
Preemption	Humped Crossing	Crossing Condition Geometry	Crossing Surface Condition	Crossing Condition Sight	Redundant Crossing	
<input checked="" type="checkbox"/>	<input type="checkbox"/>	Fair	Poor	Good	No	
Economic Impact if Closed	Feasibility of Roadway Improvements	Grade Separation Investigation	Need for Enhanced Warning Devices			
Medium	High	Low	No			
Aerials

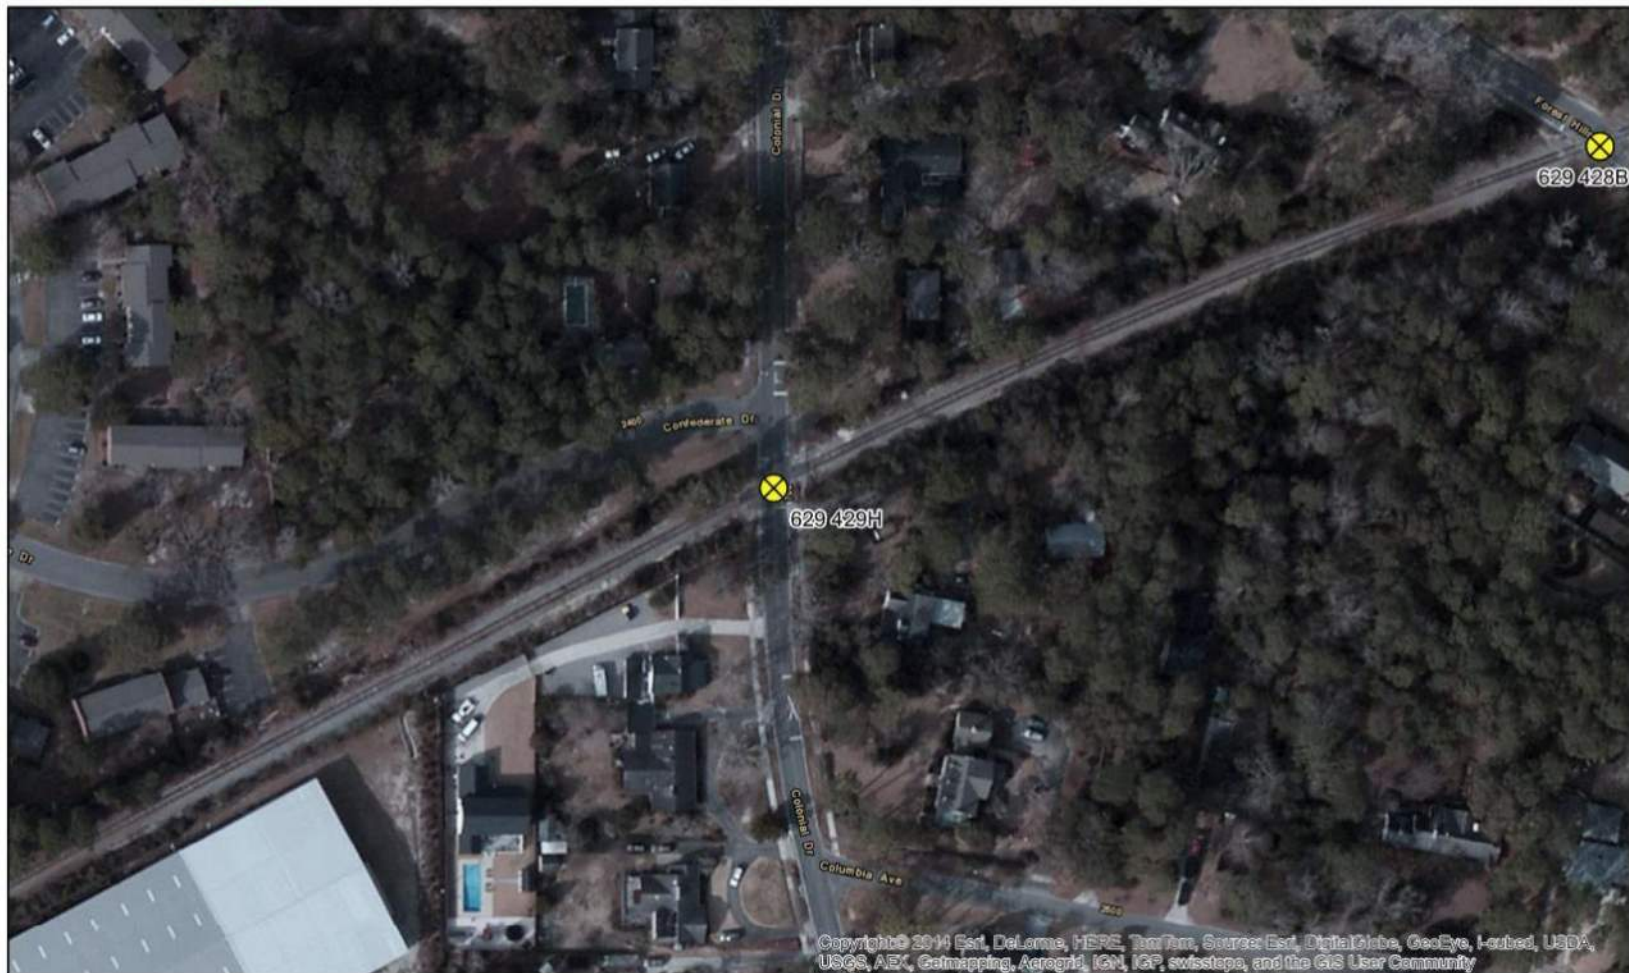
Figure 32 – Colonial Drive, Crossing Inventory

Crossing Number	Milepost	Railroad	Street Name	Street Classification	Warning Device	Land Use
629 429H	247.79	CSX	Colonial Dr.	Minor Arterial	MMFL	Residential
24 Hour ADT	24 Hour Train Volume	Accident History	Transit Route	School Bus Route	Truck Route	
3,837	3/day; 5 days/week		No	Yes - Avg.: 6/day	n/a	
Preemption	Humped Crossing	Crossing Condition Geometry	Crossing Surface Condition	Crossing Condition Sight	Redundant Crossing	
<input checked="" type="checkbox"/>	<input type="checkbox"/>	Fair	Fair	Good	No	
Economic Impact if Closed	Feasibility of Roadway Improvements	Grade Separation Investigation	Need for Enhanced Warning Devices			
Low	High	Low	Yes			
Aerials

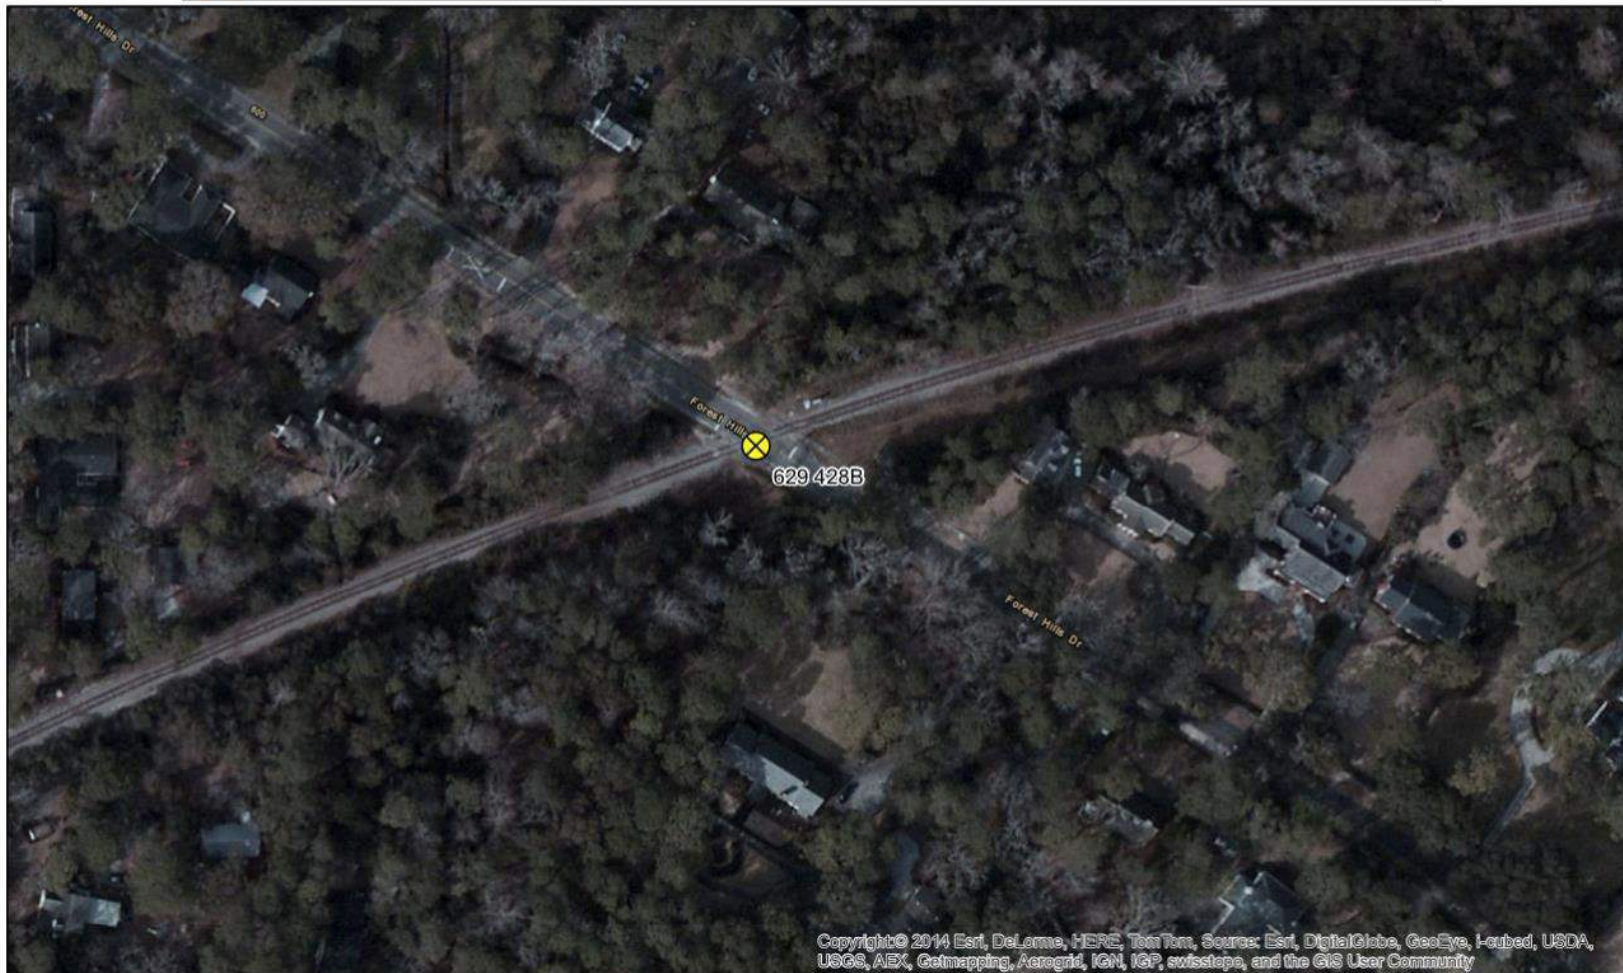
Figure 34 – Forest Hills Drive, Crossing Inventory

Crossing Number	Milepost	Railroad	Street Name	Street Classification	Warning Device	Land Use
629 428B	247.65	CSX	Forest Hills Dr.	Local	MMFL	Residential
24 Hour ADT	24 Hour Train Volume	Accident History	Transit Route	School Bus Route	Truck Route	
821	3/day; 5 days/week		No	No	n/a	
Preemption	Humped Crossing	Crossing Condition Geometry	Crossing Surface Condition	Crossing Condition Sight	Redundant Crossing	
<input checked="" type="checkbox"/>	<input checked="" type="checkbox"/>	Fair	Fair	Good	No	
Economic Impact if Closed	Feasibility of Roadway Improvements	Grade Separation Investigation	Need for Enhanced Warning Devices			
Low	High	Low	Yes			
Aerials

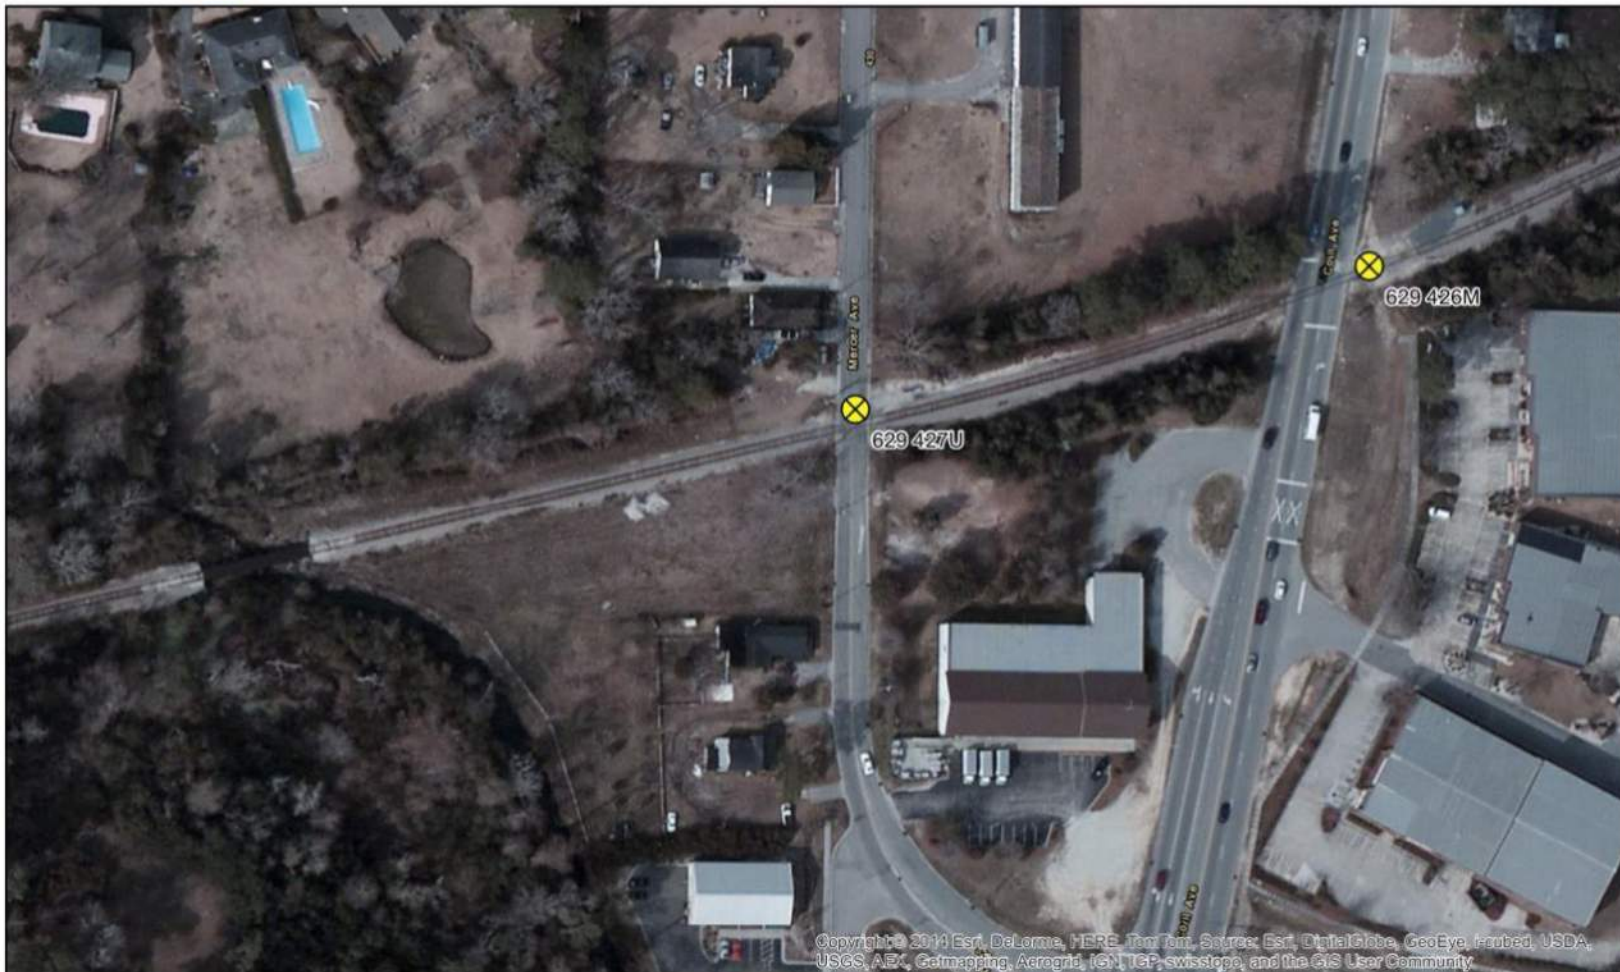
Figure 36 – McRae/Mercer Avenue, Crossing Inventory

Crossing Number	Milepost	Railroad	Street Name	Street Classification	Warning Device	Land Use
629 427U	247.37	CSX	Mercer Ave.	Local	CFL	Residential
24 Hour ADT	24 Hour Train Volume	Accident History	Transit Route	School Bus Route	Truck Route	
997	3/day; 5 days/week		No	Yes - Avg.: 6/day	n/a	
Preemption	Humped Crossing	Crossing Condition Geometry	Crossing Surface Condition	Crossing Condition Sight	Redundant Crossing	
<input checked="" type="checkbox"/>	<input type="checkbox"/>	Good	Poor	Good	No	
Economic Impact if Closed	Feasibility of Roadway Improvements	Grade Separation Investigation	Need for Enhanced Warning Devices			
Low	High	Low	Yes			
Aerials

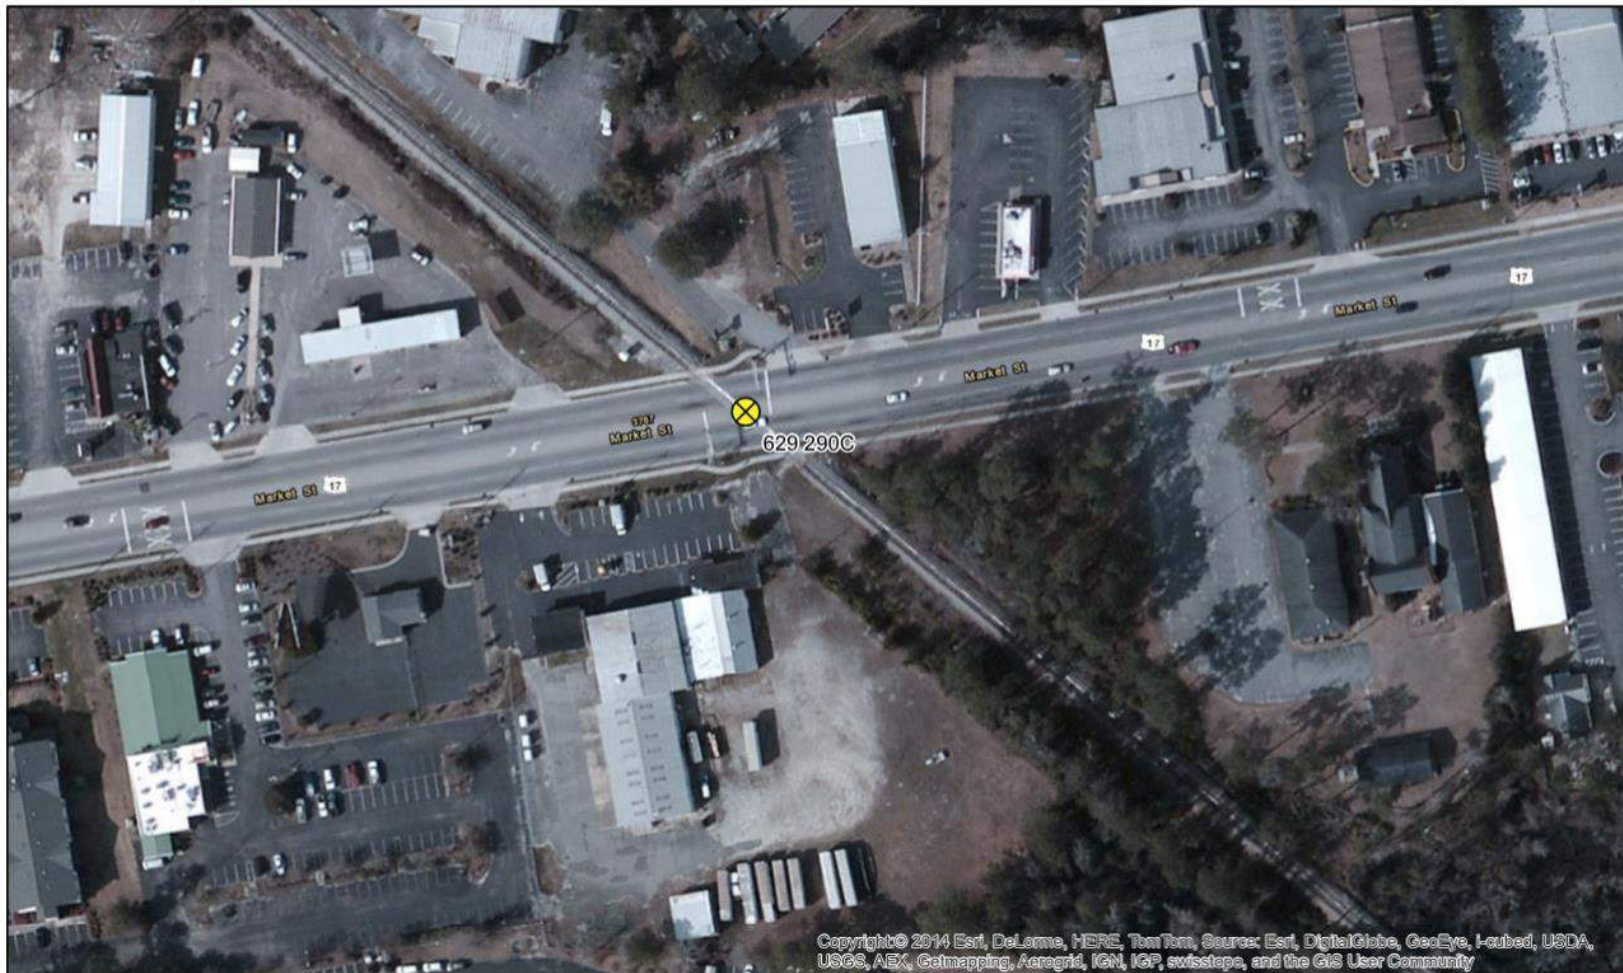
Figure 40 – US 17/Market Street, Crossing Inventory

Crossing Number	Milepost	Railroad	Street Name	Street Classification	Warning Device	Land Use
629 290C	246.24	CSX	Market St.	Urban- other principal	Gates, MMFL, CFL	Commercial
24 Hour ADT	24 Hour Train Volume	Accident History	Transit Route	School Bus Route	Truck Route	
35,920	3/day; 5 days/week		Yes	No	n/a	
Preemption	Humped Crossing	Crossing Condition Geometry	Crossing Surface Condition	Crossing Condition Sight	Redundant Crossing	
<input checked="" type="checkbox"/>	<input type="checkbox"/>	Fair	Good	Good	No	
Economic Impact if Closed	Feasibility of Roadway Improvements	Grade Separation Investigation	Need for Enhanced Warning Devices			
High	High	Low	No			
Aerials

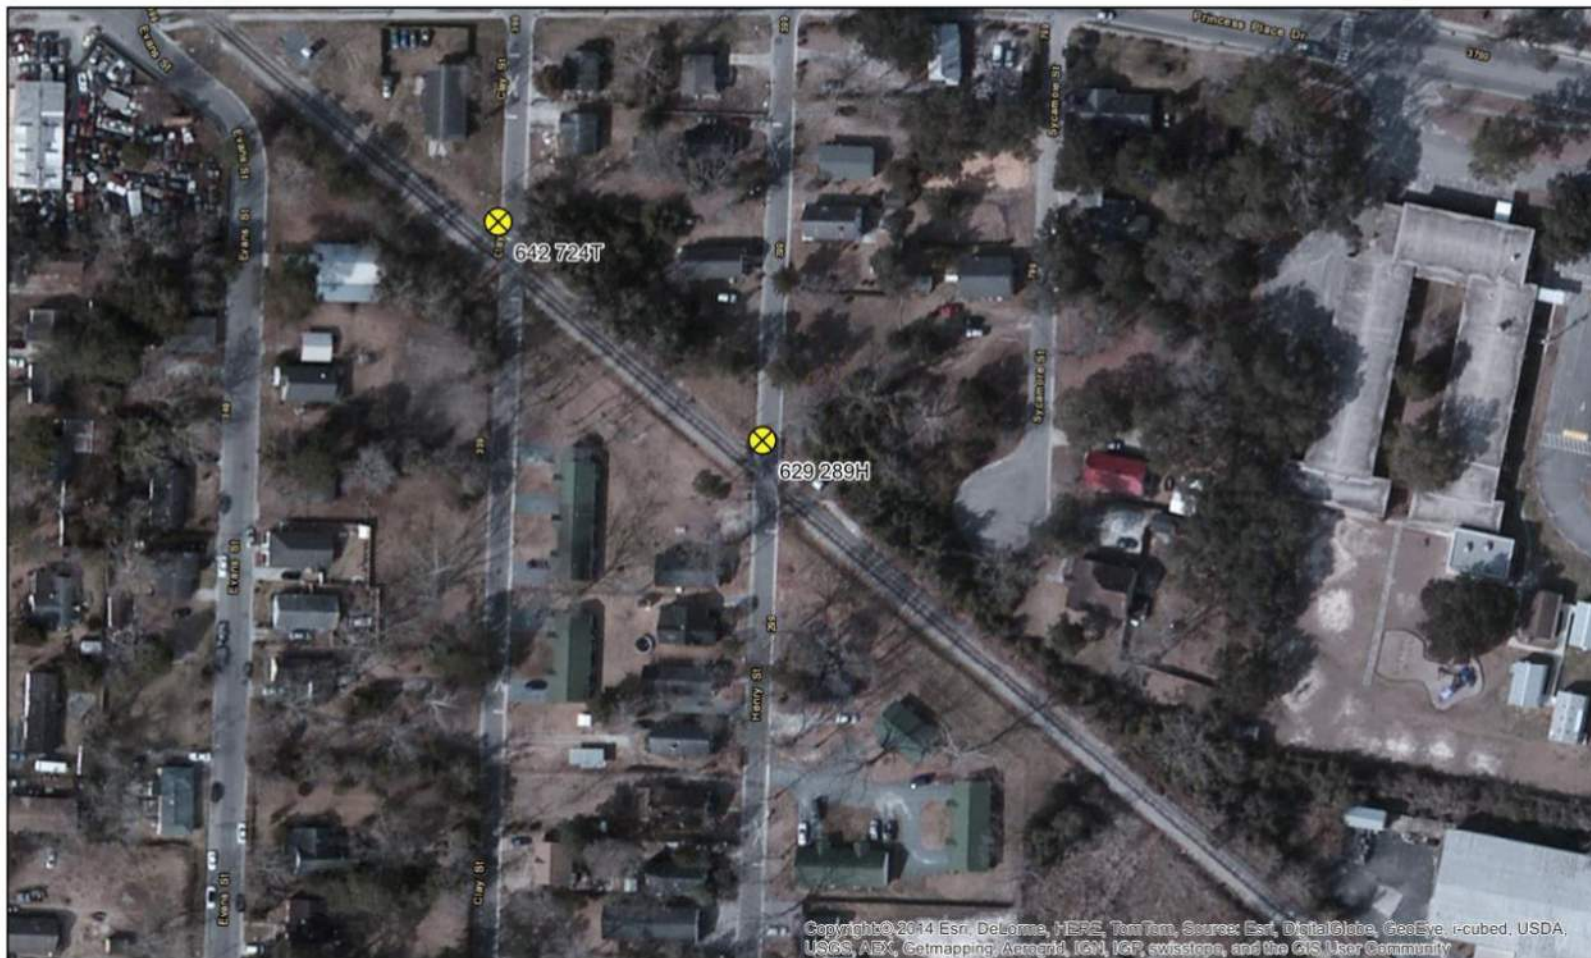
Figure 42 – Henry Street, Crossing Inventory

Crossing Number	Milepost	Railroad	Street Name	Street Classification	Warning Device	Land Use
629 289H	246.04	CSX	Henry St.	Local	Gates, MMFL	Residential
24 Hour ADT	24 Hour Train Volume	Accident History	Transit Route	School Bus Route	Truck Route	
429	3/day; 5 days/week		No	No	n/a	
Preemption	Humped Crossing	Crossing Condition Geometry	Crossing Surface Condition	Crossing Condition Sight	Redundant Crossing	
<input checked="" type="checkbox"/>	<input type="checkbox"/>	Fair	Fair	Good	No	
Economic Impact if Closed	Feasibility of Roadway Improvements	Grade Separation Investigation	Need for Enhanced Warning Devices			
Low	High	Low	Yes			
Aerials

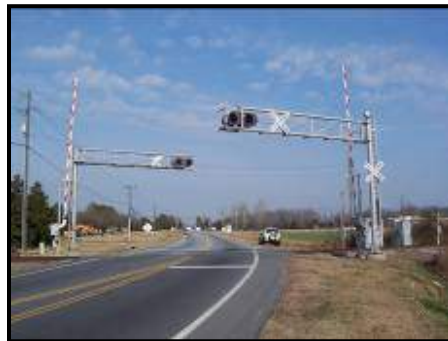
Example of gates, signs and flashing lights

The most common, and cost-effective, way to increase the safety at a railway crossing is to upgrade existing warning devices at the crossing. Typical warning devices include signs, gate arms, flashing lights and bells. *Passive* devices, such as advanced warning signs and crossbucks, merely warn the motorist of the existence of a railroad crossing. These devices are most suitable where train and traffic volumes and speeds are low, and where sight distance is adequate. *Active* devices that

warn motorists of approaching trains include flashing lights, bells, and automated gates. Such devices are usually employed at locations exhibiting higher volumes or speeds, or greater potential for accidents. The hierarchy of standard warning treatments, from least to most protected are:
