NC Department of Transportation
RAIL DIVISION

TRAFFIC SEPARATION STUDY

FEBRUARY 2017

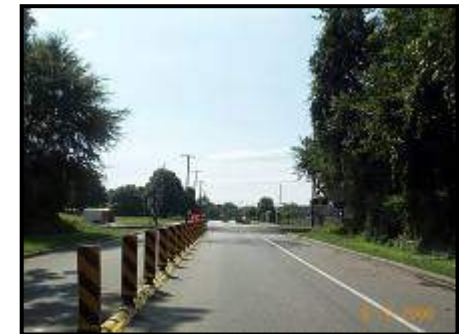
Example of Median Barriers

Median barriers consist of markers mounted on raised islands along the roadway centerline to discourage motorists from driving in opposing travel lanes to "go around" lowered gate arms. Median treatments typically extend 70 feet to 100 feet back from the gates, but may be precluded by driveways or

intersecting roads within this distance.

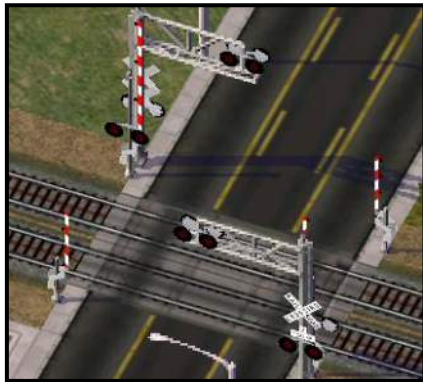
This crossing treatment requires an additional gate on each approach, completely "sealing" the crossing. Several measures are employed to prevent vehicles from becoming "trapped" inside the gates, including careful timing of the gates to allow traffic to clear; providing 16 feet of clearance between track center and gates; leaving adequate space between gate tips for a vehicle to "squeeze" out; and use of breakaway arms. In tests at the

Example of 4 Quadrant Gate

Sugar Creek Road crossing in Charlotte, four-quadrant gates alone reduced violations by 86%; in combination with median barriers, the reduction in violations rose to 98%.
